Axle Position Histogram

MTE User Manual - Classification Reports

MetroCount

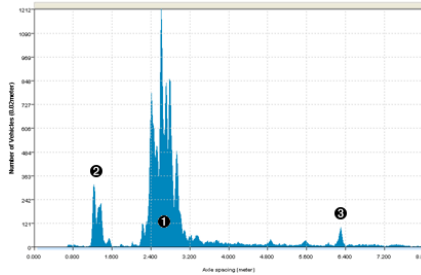
Axle Position Histogram Sample

The Axle Position Histogram is a histogram of inter-axle spacings within vehicles. This report will usually have a characteristic shape corresponding to common axle spacings, making it an extremely useful tool for verifying data quality.

1. A group of spikes representing the most common passenger vehicles, and light trucks.
2. Spikes corresponding to the double and triple axle groups of heavy vehicles (for datasets containing a noticeable percentage of these vehicles).
3. Smaller spikes corresponding to the longer inter-axle spans in heavy vehicles, such as buses.

Characteristic spikes in the histogram can be checked against known good data from the same area. If these spikes deviate in position by a significant amount, one of these problems may exist, and speed and classification should be considered suspect for this dataset.

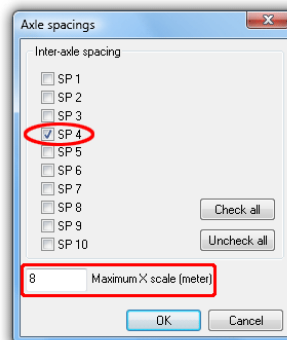
For example, it is possible to target the double axle group on the back of an articulated truck, which is usually one of a few standard distances apart. Selecting **Properties** from the report's right-click menu will display the axle spacings filter.

Selecting **SP4** in this case will display only the spacings between axles four and five. Note also the X-axis scale can be modified to increase resolution.

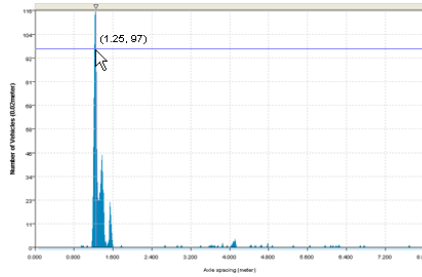
Filtered Axle Position Histogram

Filtering should create a few clearly defined spikes that can be verified using the cross-hairs. Again, deviation from known values may indicate a sensor installation problem.

For bidirectional data *with a suspected problem*, it is possible to distinguish between different sensor length and incorrect spacing. Different sensor length will result in spacings that are too short in one direction, and too long in the other. If filtering for one direction using the report Profile's direction filter moves the Axle Position Histogram left or right, this indicates different sensor length. If the report is unmoved, then incorrect spacing is the likely cause.
